# TEMPORARY OPERATING INSTRUCTION (TOI)

Subject: IFA2 cable easement and B2 layout amendment

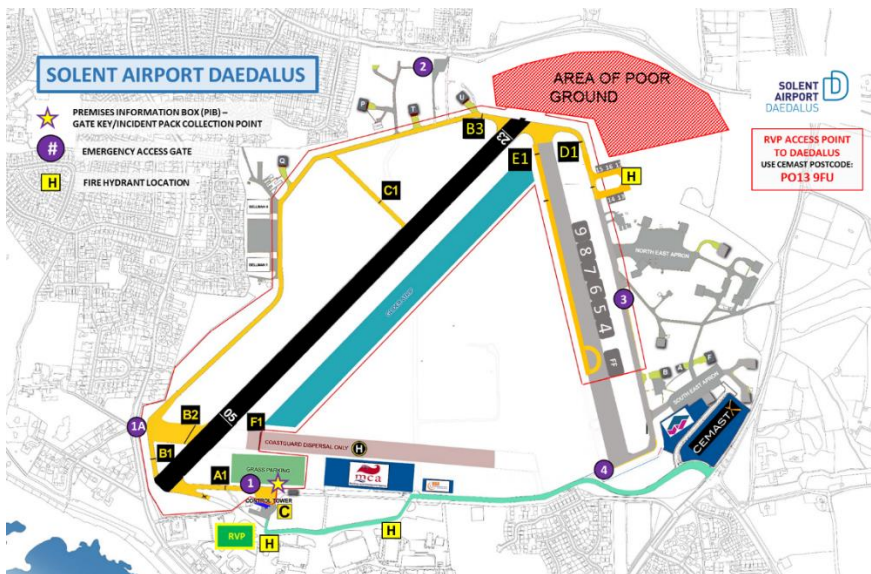
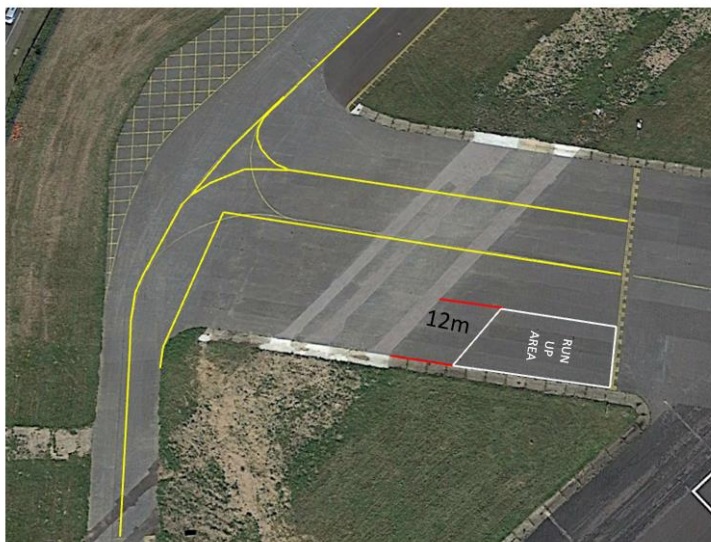
Possible Compass Error when using Runway 05 Bravo 2 hold. Some aircraft may experience magnetic disturbances, affecting the Heading Reference System. Pilots should ensure that, pre-flight are conducted within the white box or at the hold point. When positioned for take-off from Runway 05 the aircraft heading reference is checked against the runway alignment. Aircrew noticing a compass anomaly should notify ATC as soon as possible.

Run Up Area – bounded by white lines 12m from the cable trenching.

New centre line and edging with revised lead in taxiway lines.

It is recommended to maintain a distance of 12m from the cable crossings for calibrations and pre-flight checks and otherwise there should only be a short term localised compass deviation when crossing over the cables.
